AFRL-ML-WP-TR-1998-4211

ENDURANCE PUMP TESTS WITH FRESH AND PURIFIED MIL-H-5606 HYDRAULIC FLUID

JUNE 1998

FINAL REPORT FOR PERIOD APRIL 1, 1995 – JUNE 1 1998

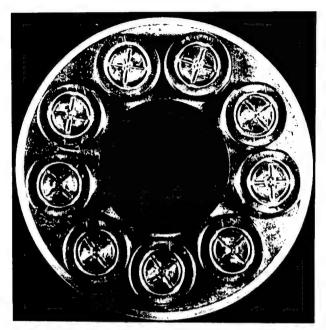
Enlargement of Piston Shoe Faces 9,1,2

The base line test was completed successfully. At 946 hours, the throttling valve stuck in the maximum flow cycle (12.5 gpm) and the test continued until 972 hours. The test was stopped to fix the problem, and to inspect the pump. The pictures taken before the test, after 972 hours and after the completion of the 1500 hours are shown in Appendix-A. Polishing wear was observed on most of the pump parts except on the cylinder block face, on the piston shoe faces and on the main shaft end that mates with the needle bearing. Some erosion was observed around the kidney ports, on the cylinder block face and on the piston shoe faces. The main shaft, that acts as the inner race for the needle bearing, showed considerable spalling possibly due to the cyclic forces at the roller bearing/shaft interface. It was decided to continue the test without replacing any parts. No degradation in the pump performance was

Piston Shoe Faces after 972 Hours Pump Test 35 with MIL-H-5606

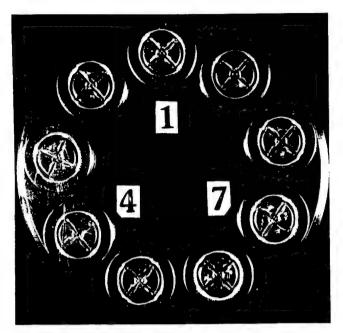
observed due to the spalled shaft or the erosion on cylinder block and piston shoe faces. The 1500 hour inspection showed an increase in the erosion around the kidney ports on the cylinder block face and on the piston shoe faces. The spalling on the shaft did not seem to increase.

Piston Shoe Faces after 1500 Hours Pump Test 35 with MIL-H-5606

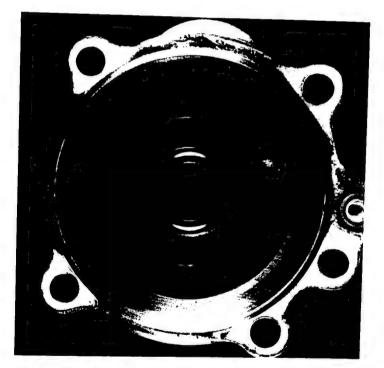
Valve Plate

Cylinder Block Faces after 1500 Hours Pump Test 35 with MIL-H-5606
